FINAL REPORT OF MILITARY POTENTIAL TEST OF A DOPPLER NAVIGATOR IN A FIXED-WING AIRCRAFT

DA PROJECT NO. 1G641203D526

USATECOM PROJECT NO. 4-4-4305-01

30 SEP 1964

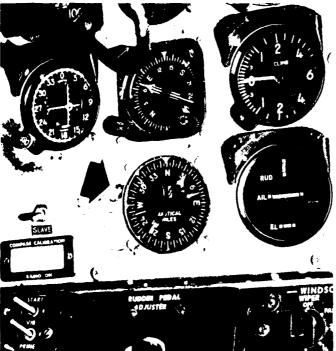
Figure 3. Installation of Bearing Distance Heading Indicator (BDHI).

- 2.11.3.1. Bearing Distance Heading Indicator (BDHI) lighting was inadequate.
- 2.11.3.2. Computer was difficult to program. The slewing knobs were difficult to operate because of high friction levels. The counters were difficult to position accurately because they continued to turn after the knob was returned to the neutral or stop position.
- 2.11.3.3. Destination counters creeped during flight. This could be serious if pilot lost or forgot the data he had inserted.
- 2.11.3.4. The present position and destination markings indicate only north and east. This was confusing to some pilots when south and west coordinates were inserted into the computer.

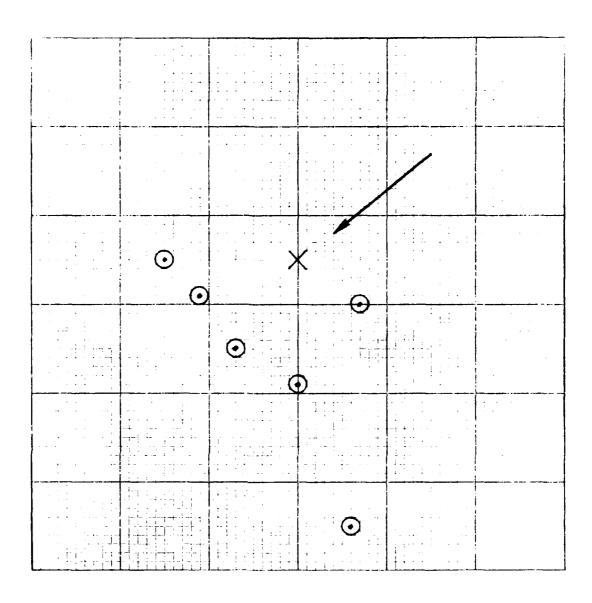
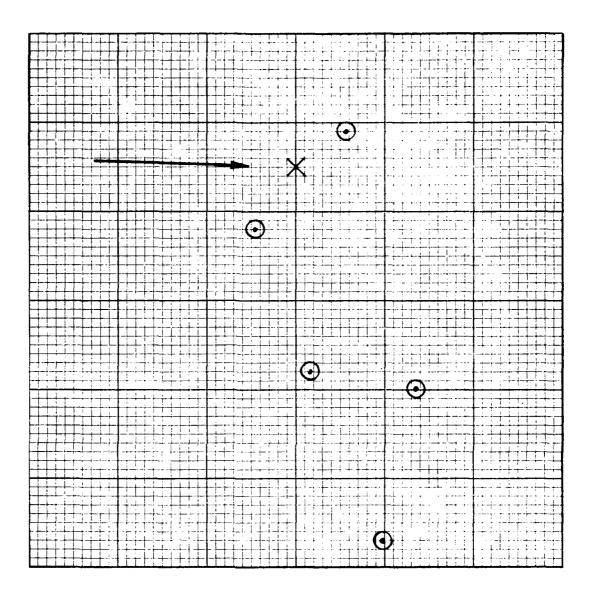
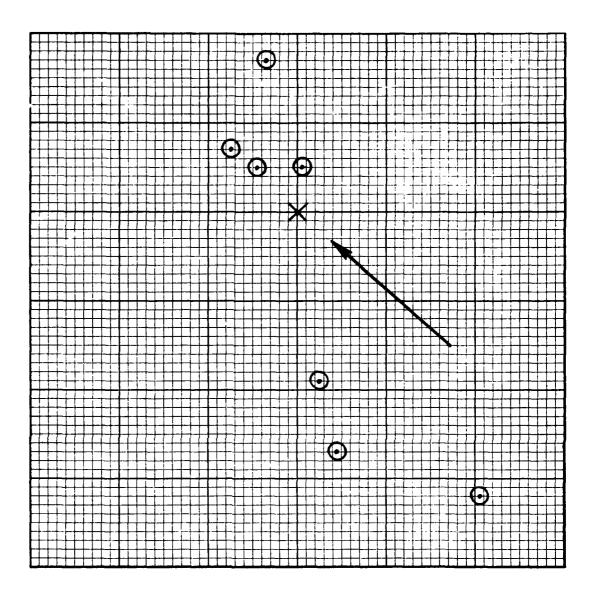
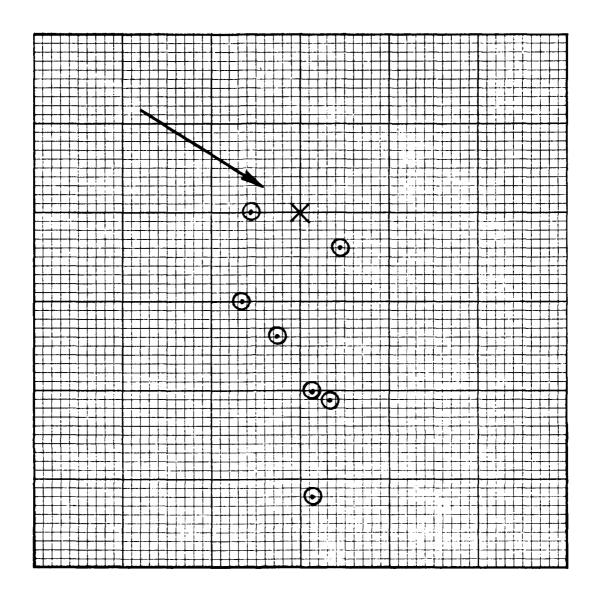
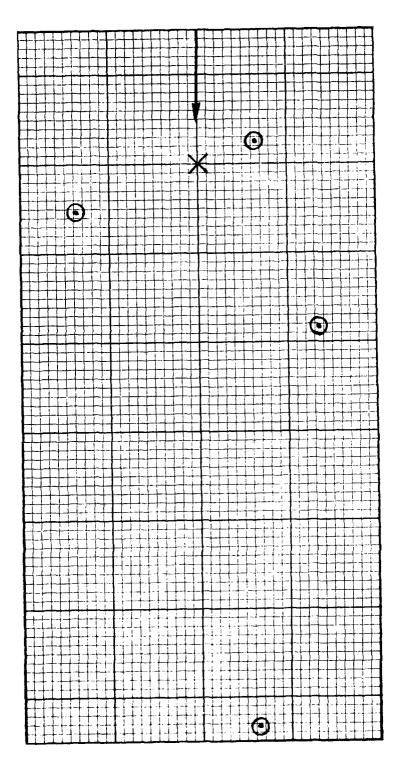
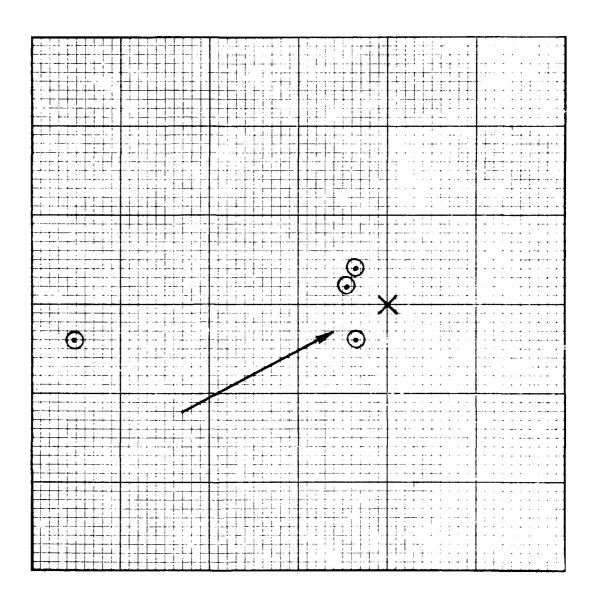
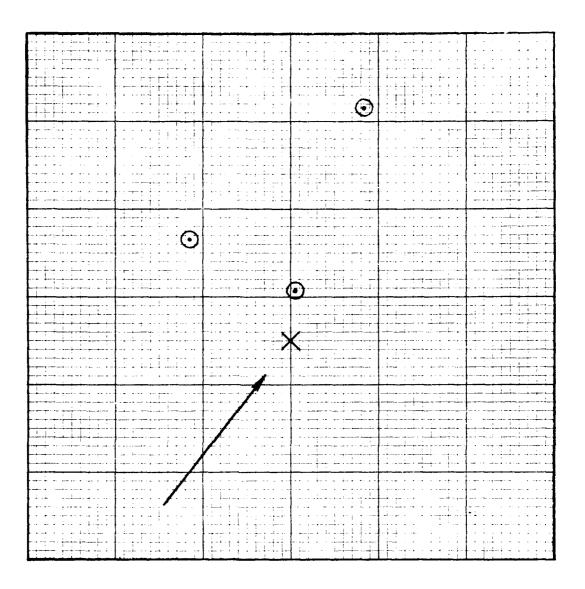
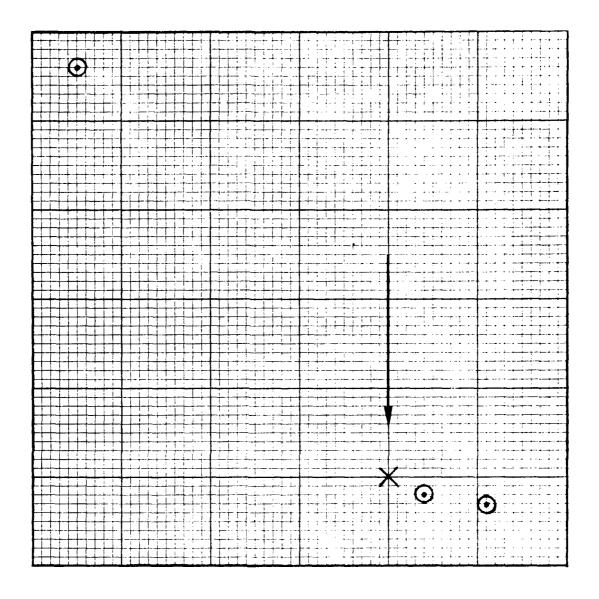
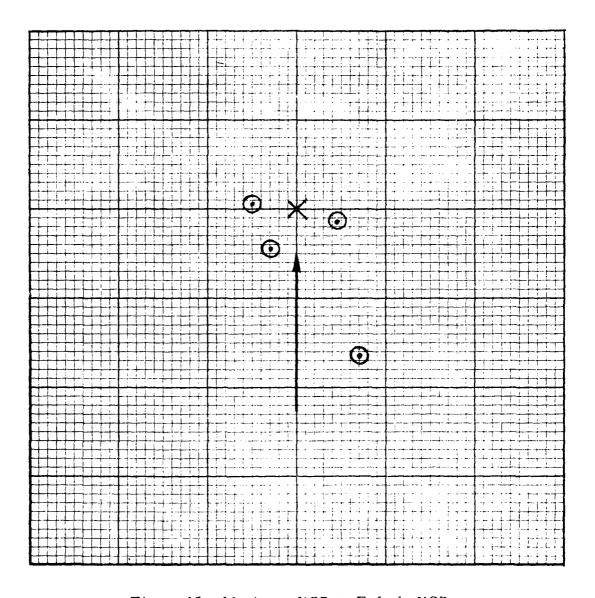
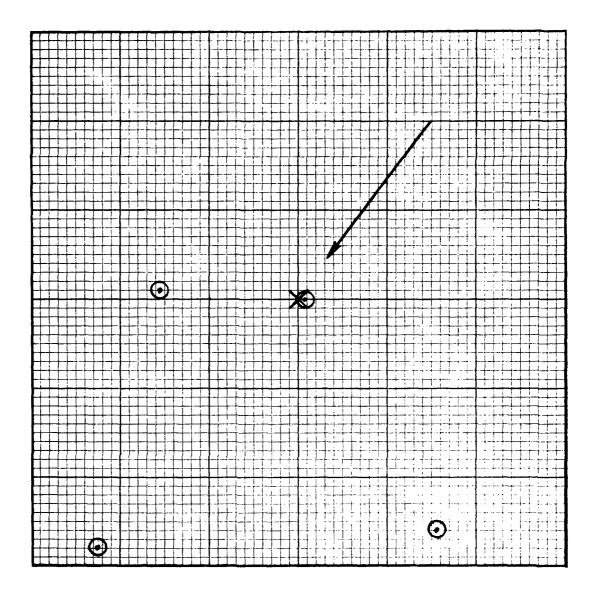
Repeatability of the system was unacceptable because of the wide dispersion of the flights as shown in figures 7 through 16 and position errors that ranged from .05 percent to 4.85 percent.

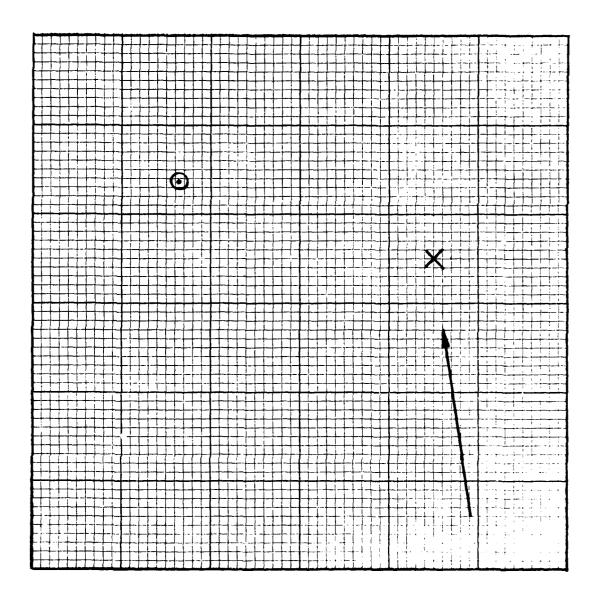
Figure 17. Tampa VOR to Cross City VOR (Overwater Flight)
Distance: 191.3 Kilometers

- 2.4.3.1. The distance-traveled error for the overwater flight was 1.57 percent. (See appendix I, part B.)
- 2.4.3.2. Wind-memory operation could not be tested because the true-airspeed transducer was not compatible with the MINAC-6 computer due to conflicting scale factors.

System accuracy of 1.57 percent for the overwater flight was comparable to the overall system accuracy of 1.69 percent, both of which failed to meet accuracy criteria established in the Military Characteristics (reference 1) and SCL 5953 (reference 3).

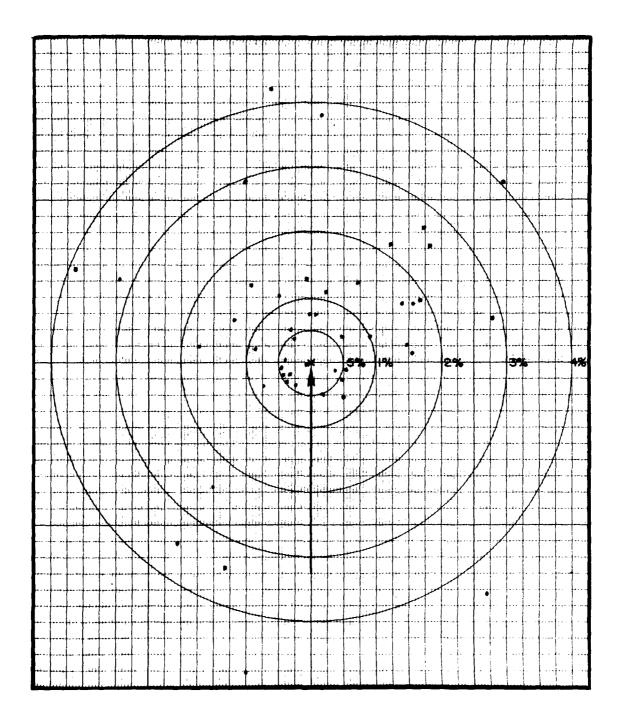
Figure 18. Overall performance. (All flights were reduced to a common base of 100 kilometers. Distance errors were reduced and positioned accordingly.)
